SERVICE INFORMATION DIRECTIVE
Compliance Will Enhance Safety, Maintenance or Economy of Operation

SID 05-1

SUBJECT: THIS SERVICE INFORMATION DIRECTIVE (SID) SUMMARIZES INFORMATION PERTINENT TO THE DESIGN, OPERATION, MAINTENANCE AND WARRANTY FOR TCM CAMSHAFTS AND HYDRAULIC LIFTERS

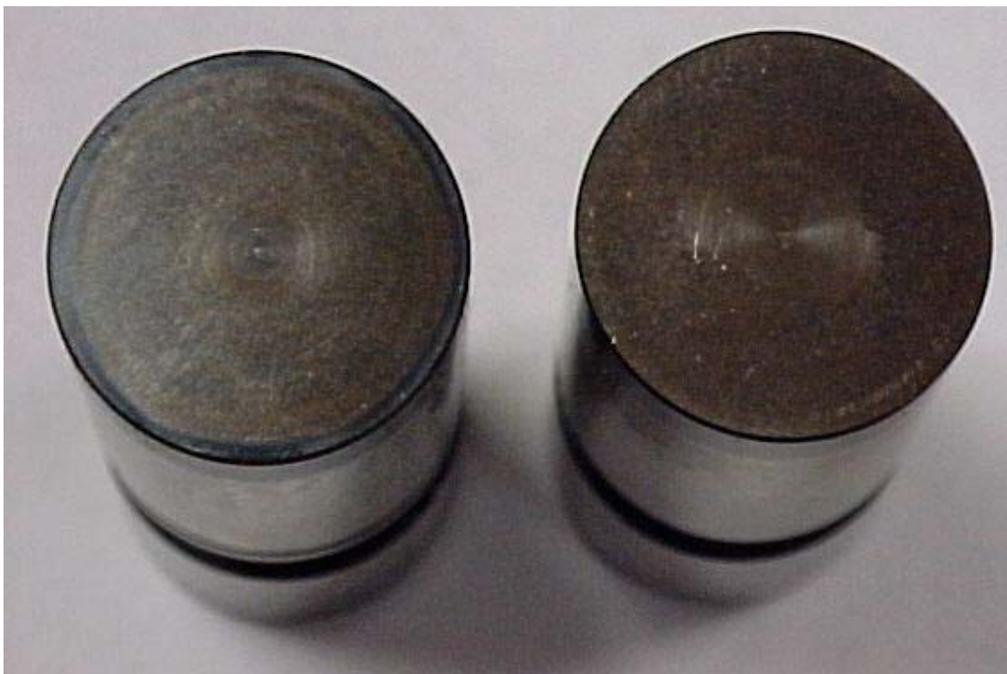
FIGURE 5 TYPICAL LIFTER FACES FROM SERVICE

The cam lobe / lifter interface is designed to wear to some extent during service life and the lifter and cam lobe “break in” together similar to piston rings in a cylinder bore. Such wear is normal as are circular wear patterns on the face of the lifter and polishing of the cam lobes. Circular scratches may also result from hard particle passage and will not effect operation.

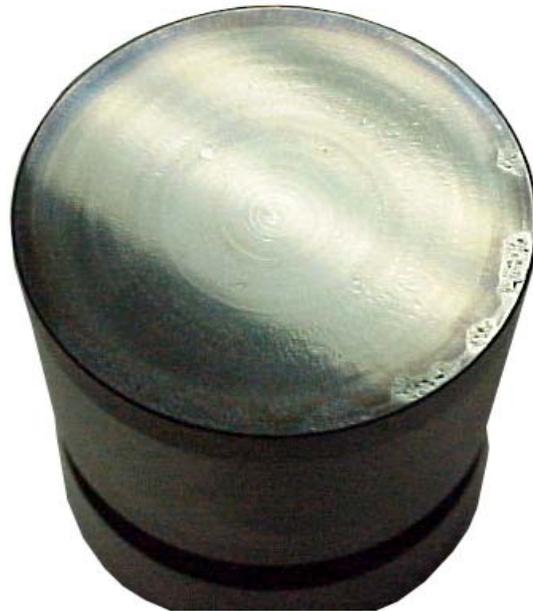
FIGURE 6 MINOR SPALLING

Minor spalling due to corrosion or other factors will not affect operation as the loads are redistributed to the surrounding material. The appearance will be some number of separated spalled areas with polished contact patterns on the remainder of the face. (Reference Figure 6)

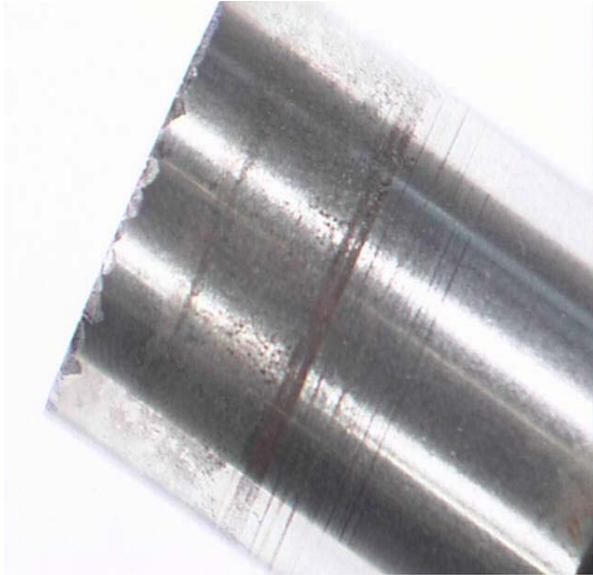
Since the camshaft is steel and the lifter body is iron, rust or corrosion is by far the most common reason for lifters to spall. The pits caused by corrosion are stress concentrations that result in spalling.

CORROSION ETCHING ON BODY

FIGURE 7 LIFTER CORROSION AND SIGNIFICANT SPALLING

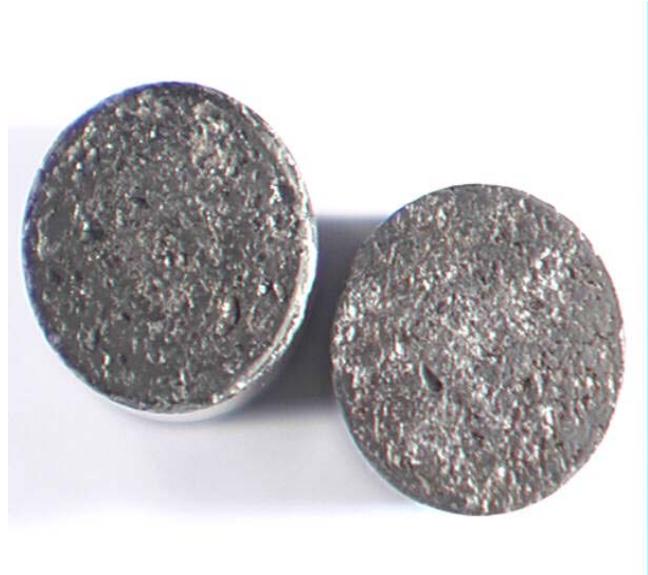
FULL FACE SPALLING

In some cases, significant spalling may result in some damage to the cam lobe apex. This level of damage is rare, but will manifest itself as surface cracks on the nose with some depth. Note that appearance of the cam lobe apex may vary normally, and only if such cracks are present should the camshaft be considered a candidate for replacement. Corrosion (rust) will also cause cam lobe distress. See the INSPECTION SECTION for specifics.

Replace lifters with severe face or lifter body wear signatures or spalling that exceeds 10% of the surface area. Lifters associated with noise indicating excessive valve lash should also be replaced regardless of face condition.

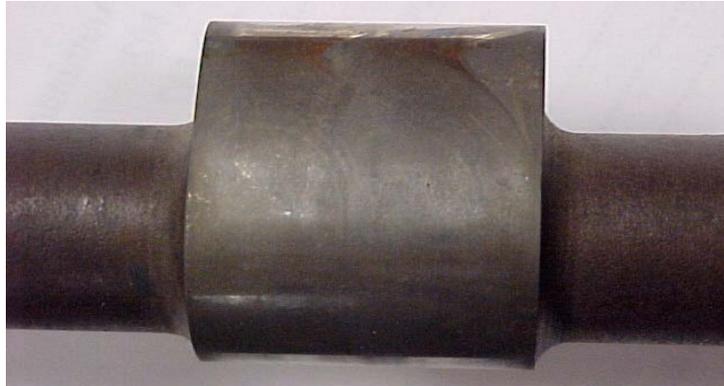
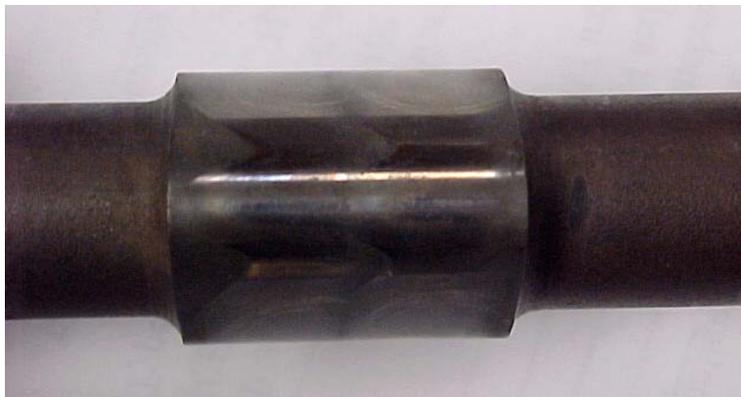
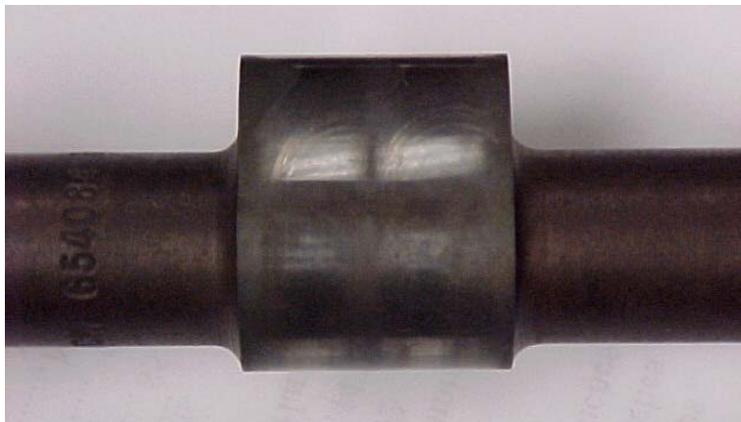
FIGURE 11 TYPICAL CAM LOBE WEAR SIGNATURES

CAM LOBE OPENING FACE

APEX OF CAM LOBE

CAM LOBE CLOSING FACE

(2) Perform visual inspection using an inspection light. If the surface is smooth and shiny with only small areas of rough appearance, no further action is required.

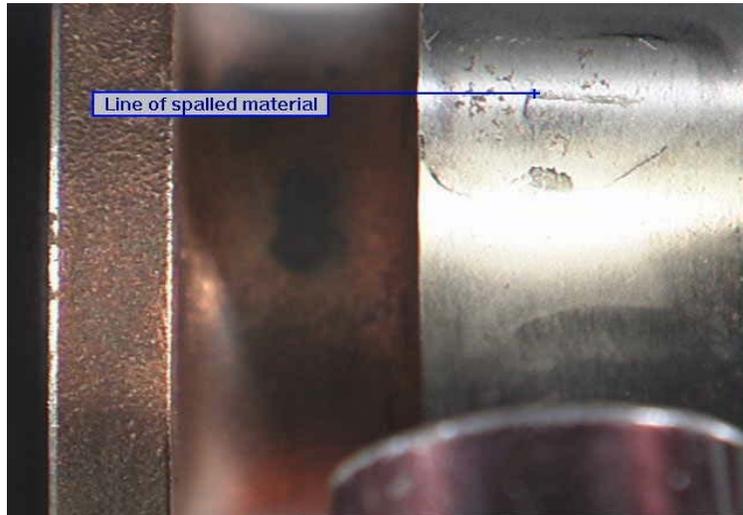
(3) If the visual inspection indicates the presence of crack like features in the surface along the cam lobe apex, proceed as follows:

SPALLED CAM LOBE

FIGURE 12 SUSPECT CAM LOBE APEX SIGNATURES

Using a sharp pick, move the point over the nose. If a crack like feature has any depth, the pick will catch in the groove or pits. If no positive indication of a crack is felt, no further action is required. If an indentation is present, the cam must be examined by a TCM service representative to determine the next steps.

NOTE
CONTACT TCM SERVICE DEPARTMENT TO ARRANGE EXAMINATION OF THE
SUSPECTED AREA BY A TCM SERVICE REPRESENTATIVE.

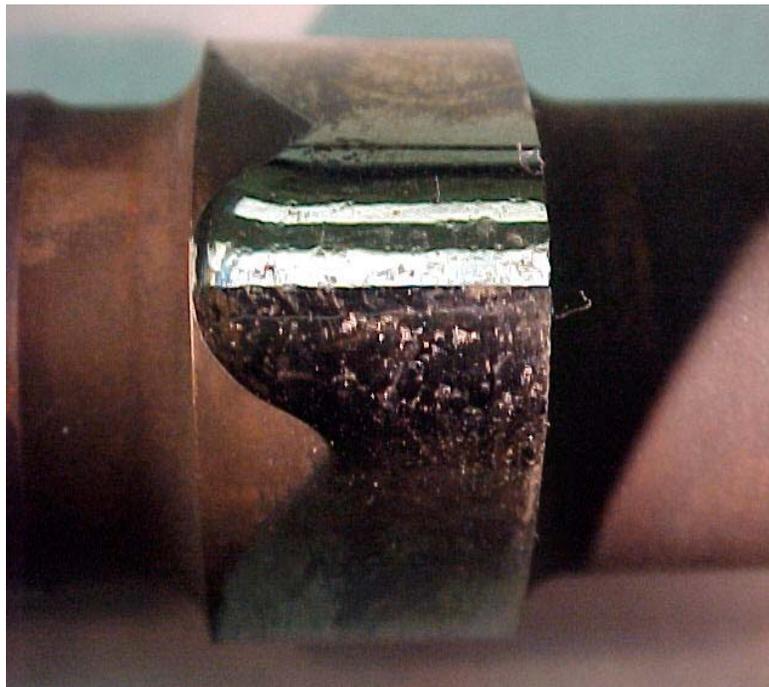
CORROSION PITTED CAM LOBE
