American Bonanza Society
Air Safety Foundation

Landing Gear Inspection Checklist and Repair Guide

For Beechcraft Bonanza, Debonair,
Baron and Travel Air

Landing Gear Repair Guide

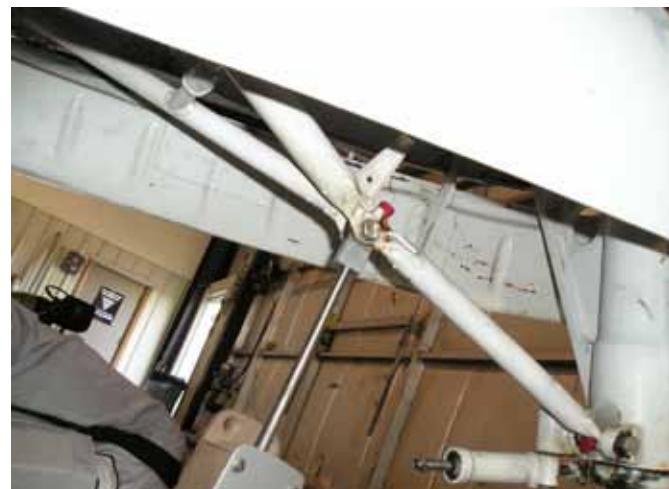
Checking the nose gear down tension with a mechanical push-pull force gauge.

Using a calibrated mechanical or digital push-pull force gauge, push on the knee joint of the lift leg and check the force required to deflect the joint. Record the results of all three landing gear and compare them to the tolerances listed by model in the maintenance manual. Note: keep push-pull force gauge approx. 90 degrees to lift leg when performing this check. On twin-engine aircraft equipped with the positive downlock mechanism, this system must be disconnected in order to perform a main gear down lock tension check.

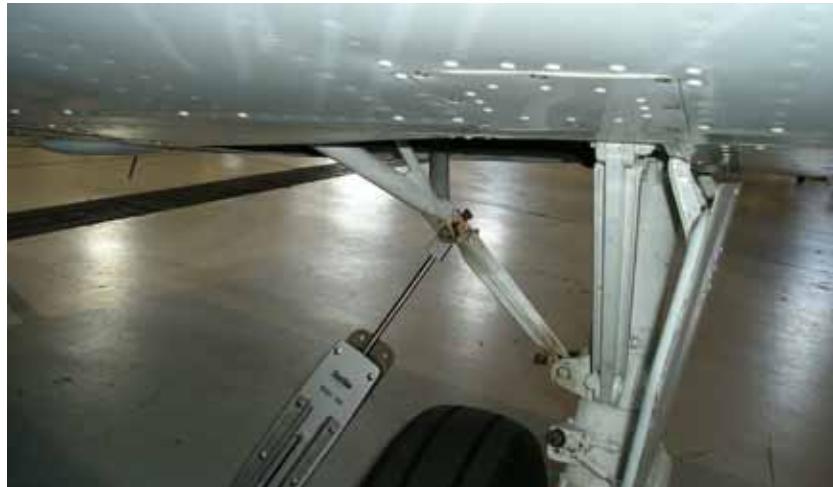
Checking downlock tension on the main landing gear.

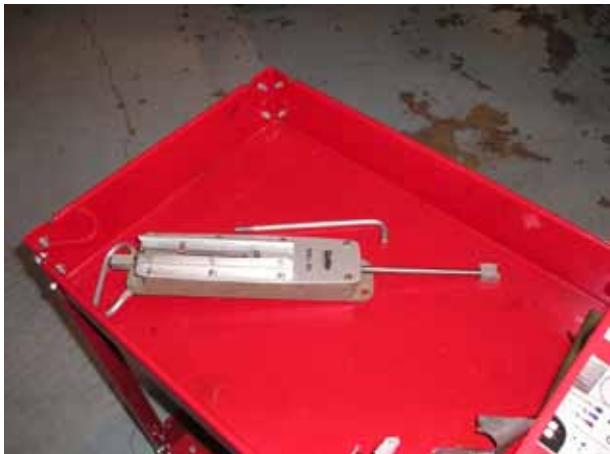
Chattillon Model 80D mechanical push-pull force gauge. This commonly used gauge is no longer in production.

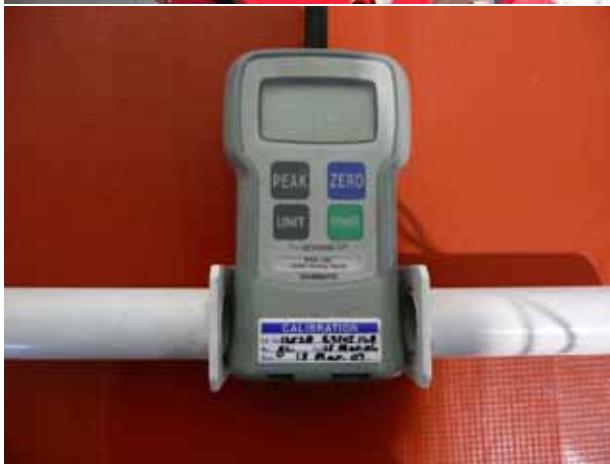
Shimpo FGE-100 digital push-pull force gauge. Note there are several models of push-pull force gauges that can be used.

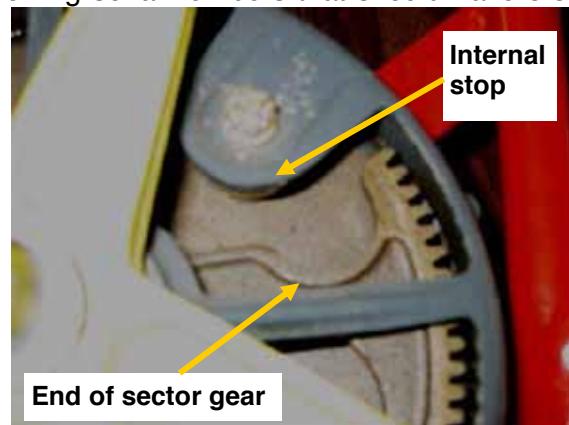
Cutaway of a gearbox showing the sector gear approximately six turns of the hand crank from the end of cycle, but not contacting the internal stop.

If the handcrank has less than these turns remaining with the gear down under normal circumstances, the dynamic brake may not be stopping the gear motor in time to prevent the gear box from contacting an internal stop at the end of the extension cycle. This in turn can cause the gearbox's sector gear to bend, crack or fail. If the handcrank turns too far in this condition, the gear motor and/or dynamic brake may be stopping the gear before it is fully locked down. This risks a gear collapse. This condition may also be indicated by an inner main gear door or doors that do not fully close. **STOW THE HANDCRANK.**

Note: If the sector gear hits the stop in either the extended or retracted position, the gearbox and motor should be removed and overhauled. The most common cause of this condition is a gear motor that is overdue for overhaul. If the motor's brushes are worn, springs are weak or the commutator is dirty or worn the motor will not stop instantly and will drive the sector gear into the stop. Do not attempt to replace motor brushes in the field. Brushes need to be run in for good brush contact with the commutator and provide proper dynamic brake operation. Send gear motors to a qualified shop for overhaul.

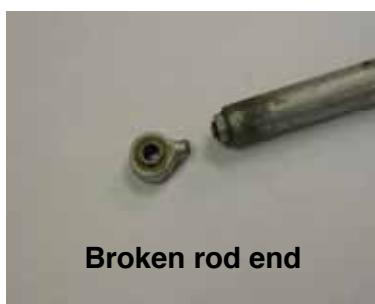
Broken rod end

Worn and failed rod ends are commonly found as possible contributors to gear collapse and mechanically caused gear up landings. ABS recommends preemptive replacement of all rod ends on condition or at 2000 hours in service, whichever comes first.

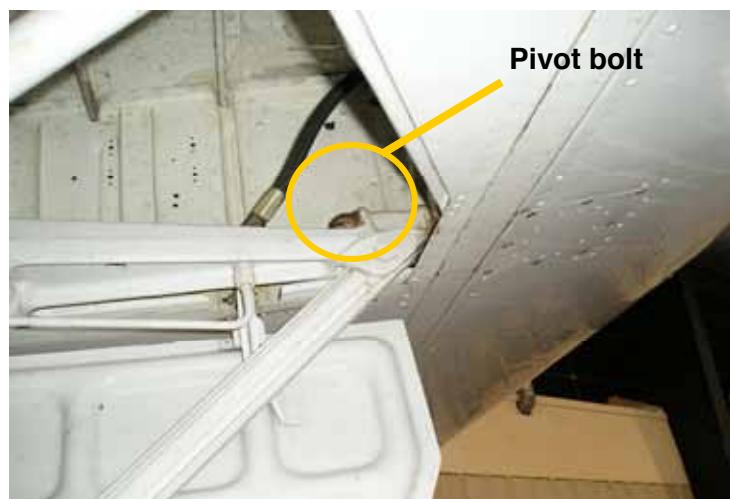
Pivot bolt

15. Check the pivot bolts that attach the main landing gear struts to the spars.

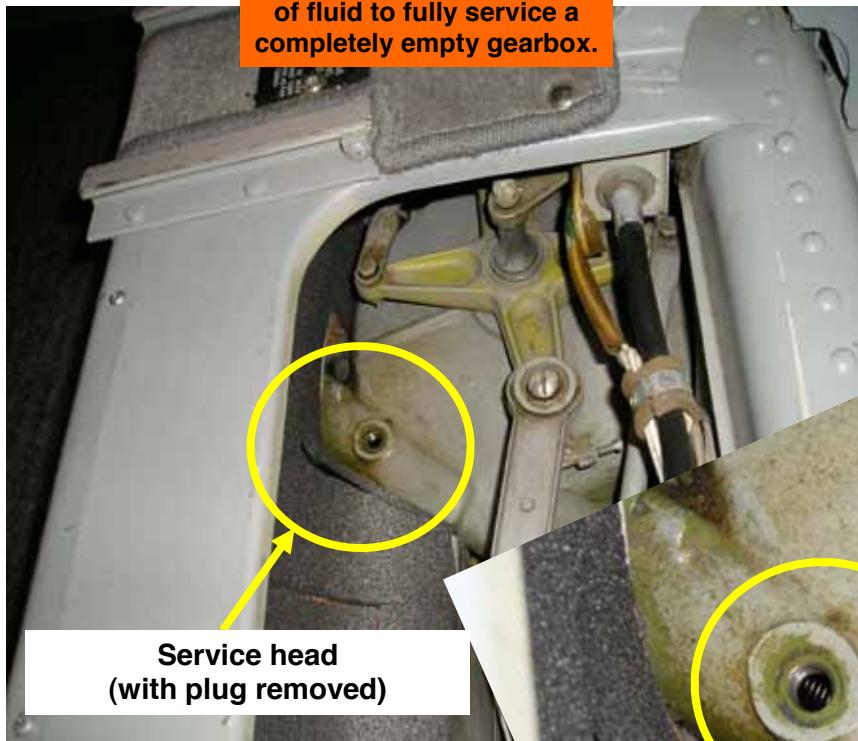
Looking down at the gearbox, beneath the copilot seat

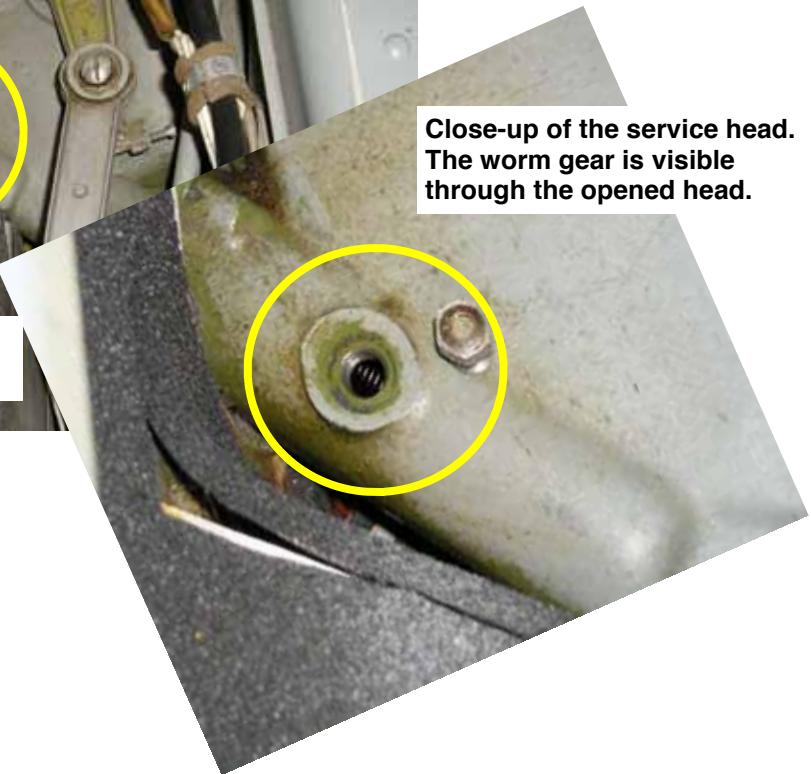
Close-up of the service head. The worm gear is visible through the opened head.

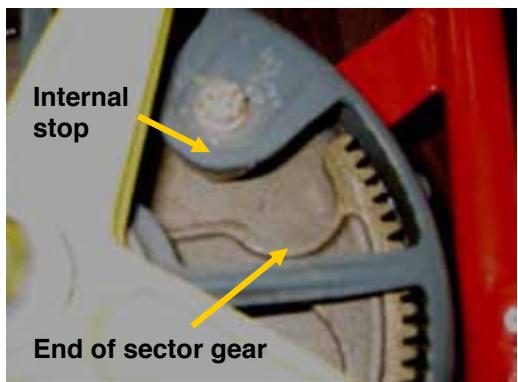
Sector gear near but not contacting the internal stop.

Gearboxes originally painted green should have 1/8 to 1/4 turn tolerance and gearboxes originally painted white should have 5/8 to 3/4 turn remaining at the end of electric travel. Many airplanes have been retrofitted with earlier or later gearboxes, and many originally green gearboxes have been erroneously painted white when overhauled.

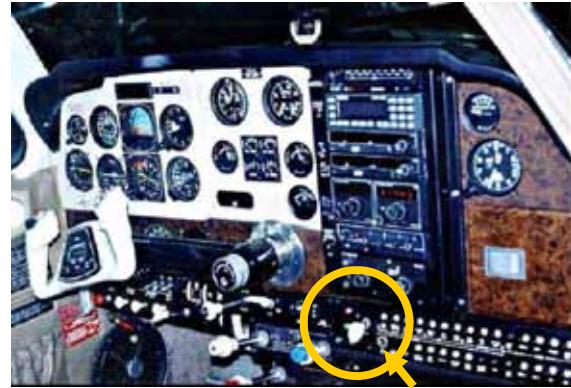
Gear selector and circuit breaker

Early aircraft have a single circuit breaker that controls both the gear motor and the gear warning and indicating systems. In these airplanes, reset the circuit breaker before testing the gear warning horn.

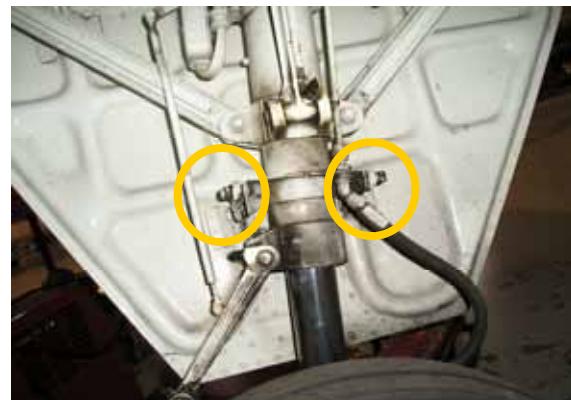
Outer gear door connection points

To reconnect the outer door the hardware sequence is: Both fore and aft bolt heads face the strut. The forward connection is bolt through the bracket, two washers, the link rod end, one washer and the nut. The aft connection is the bolt through the bracket, one washer, the link rod end, one washer and the nut.

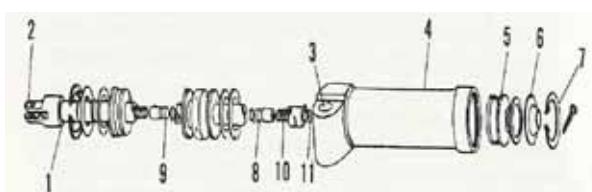
Shimmy damper

The shimmy damper should have no play, and show no sign of leaks.

NOTE: Lord Corporation has a fluid-free shimmy damper available for installation on all models under an STC.

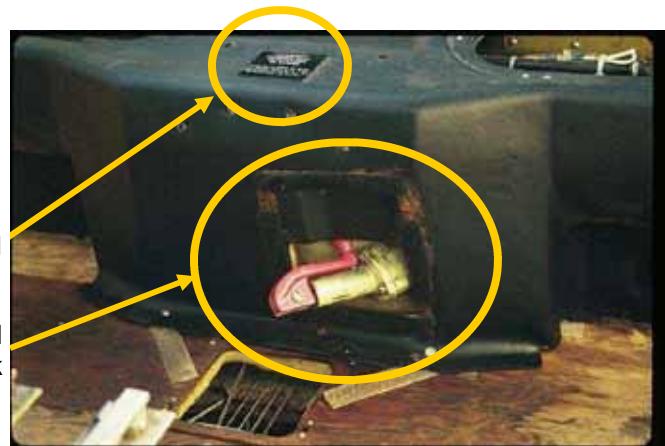
Placard
Improperly installed spar cover and obstructed handcrank

It is quite common that mechanics install the forward spar cover (in later models) so that the hard plastic covers the stowed landing gear emergency handcrank. The plastic is very hard and tolerances in this condition very tight. It is not possible to unstow the handcrank in this condition, so it would prevent a manual landing gear extension in the event the gear could not be extended electrically.

38. After the cabin inspection is complete, ensure the manual extension handle is stowed and it is not blocked by the spar cover. Install the protective boot or cover.

The protective boot or cover helps keep the handcrank stowed when passengers or baggage might otherwise contact the handcrank and cause it to come unstowed. This in turn can cause the handcrank to bind against something when the gear is run electrically and the engaged handcrank turns. It is possible to strip out the handcrank connection or damage the gear motor if the handcrank meets resistance.

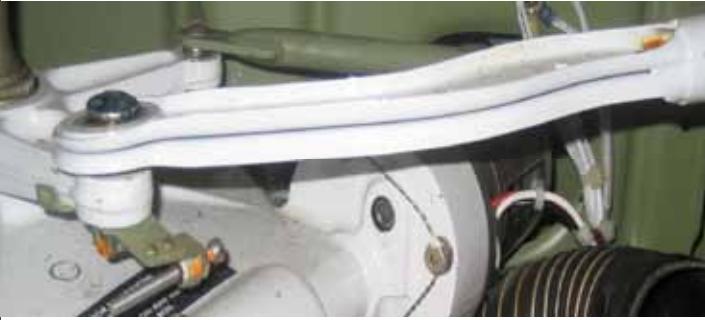
2. Main landing gear retract rod flexing/bending in the flat area. The flexing of the rod will reduce down tension to the lift leg by not fully compressing the spring on the plunger.
 1. Inspect the flat area of the retract rod for flexing up or down. Preload the rod by lifting the main wheel and collapsing the plunger on the outboard end of the rod, or watch the operation of the rod during an extension cycle for flexing. A frozen plunger may cause this problem.

Flat area of the retract rod
 2. If the rod is flexing / bending replace the retract rod.
 - (1) Pull the landing gear circuit breaker.
 - (2) Lift the main gear to compress the down tension spring.

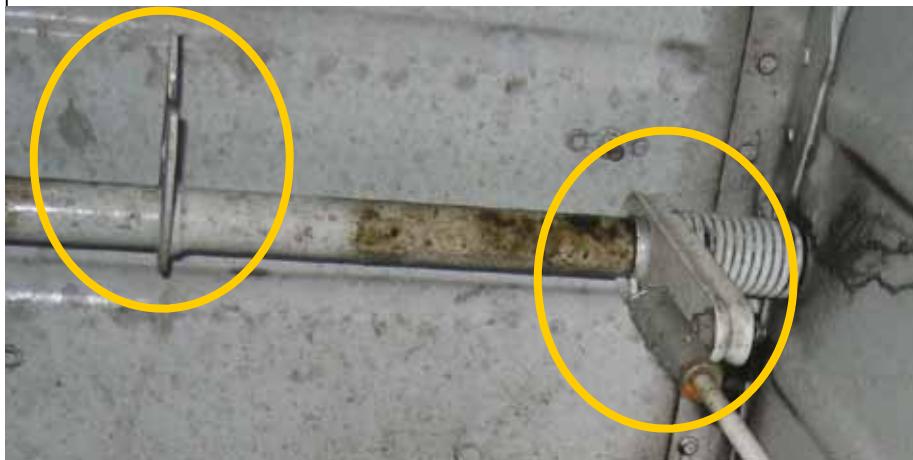
Nose gear door actuator arm (right) and door actuator pin guide (left)

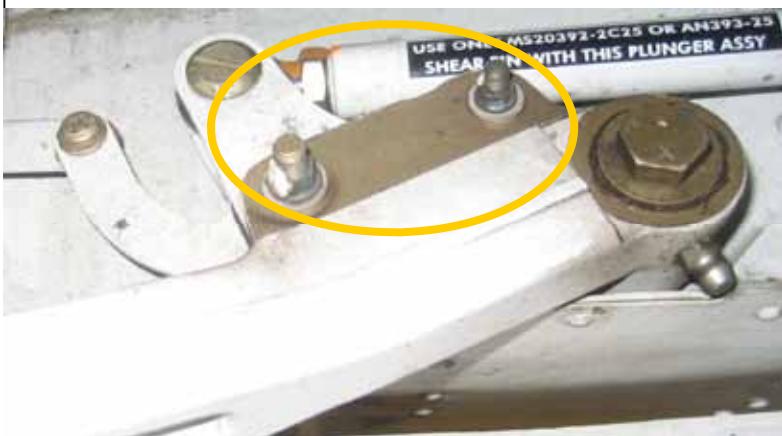
Retract rod mounting bolts

Beechcraft recommends a 2,000 hour inspection of the two (2) bolts and two (2) drag brace brackets. (NOTE – the Illustrated Parts Catalog refers to the brackets as inboard and outboard arms.)

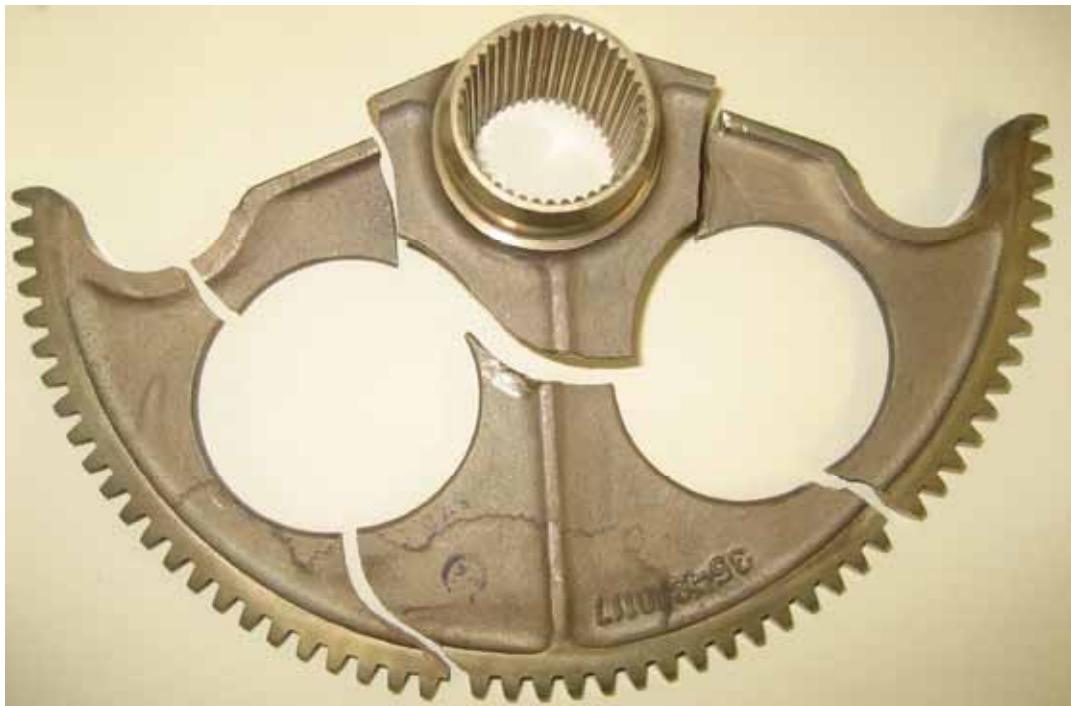
The sector gear from a 28-volt airplane that hit the internal stop on both sides repeatedly for a long period of time. The sector gear became work hardened and brittle, and eventually shattered.

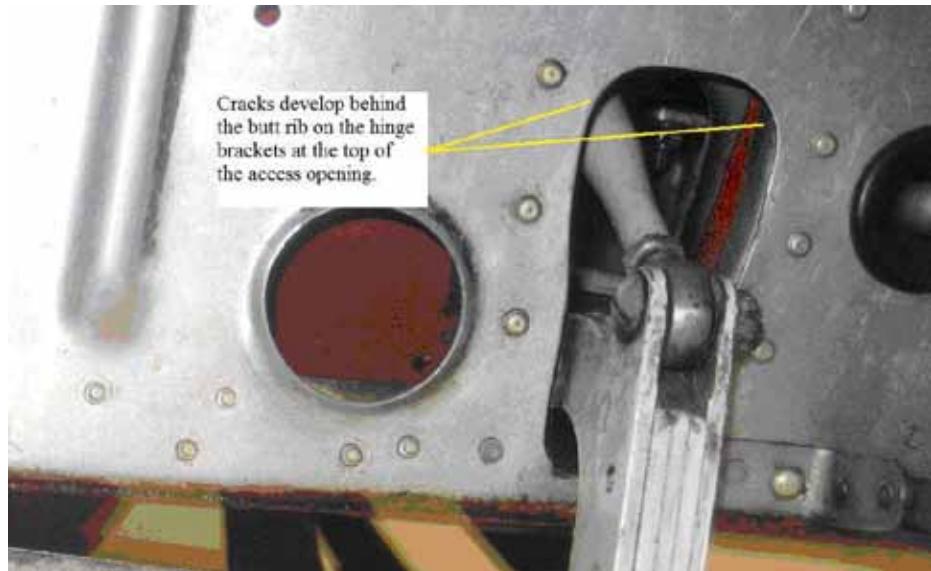
Forward hinge brackets will crack occasionally on the forward and aft sides of the access hole. You may have to remove the lower wing root fairing for access.

- (1) Manufacture a small doubler with a 90-degree angle to reinforce the bracket.
- (2) Install doubler with structural adhesive and rivet to the butt rib with Cherrymax-type blind rivets.

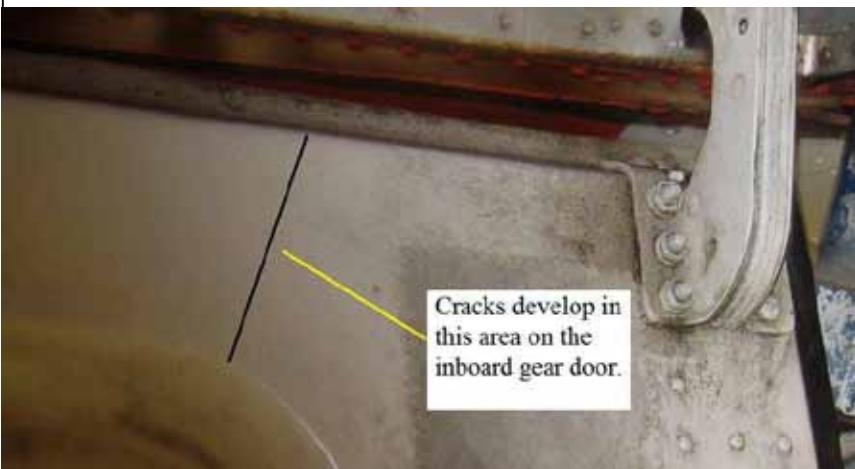
Discrepancy: Main gear inboard door cracks

A locally manufactured doubler (this may take some craftsmanship) installed with structural adhesive and blind rivets makes a good repair. Use scrim cloth with the adhesive.

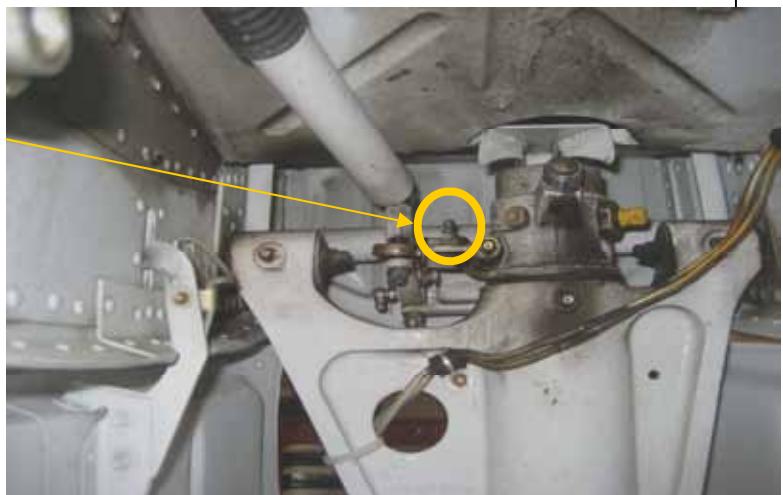
Top of the nose gear strut. Note the grease fitting is installed incorrectly, a common mistake. The fitting should be installed pointing *down* to avoid interference during gear transit and to facilitate greasing.

- (1) Remove the steering yoke from the strut cap.
- (2) Support the yoke in a bench vice.
- (3) Break off the pressed-in grease fitting (P/N 1736).
- (4) Use a pin punch to drive the remaining section of the zerk through the bushing.
- (5) Use a new bushing to push out the old bushing, then install the new bushing.
- (6) Drill a grease port in the bushing and press in new grease fitting. Install the yoke with grease fitting down to prevent interference when the gear is in transit.

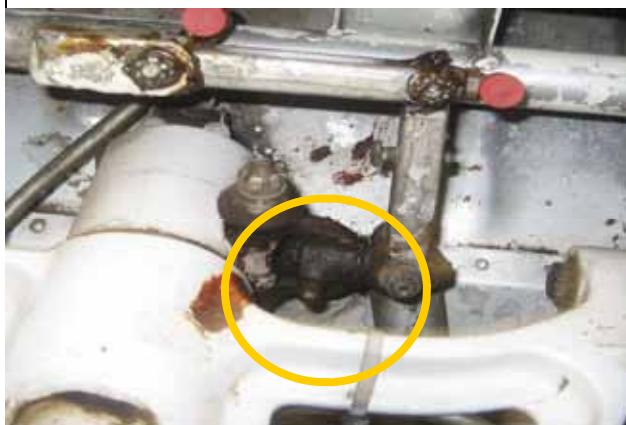
(above) Properly installed grease zerk, pointed down.

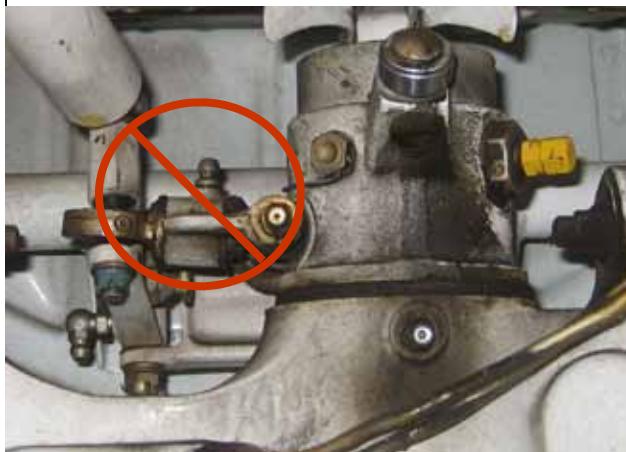
(below): Improperly installed grease zerk, pointed up.

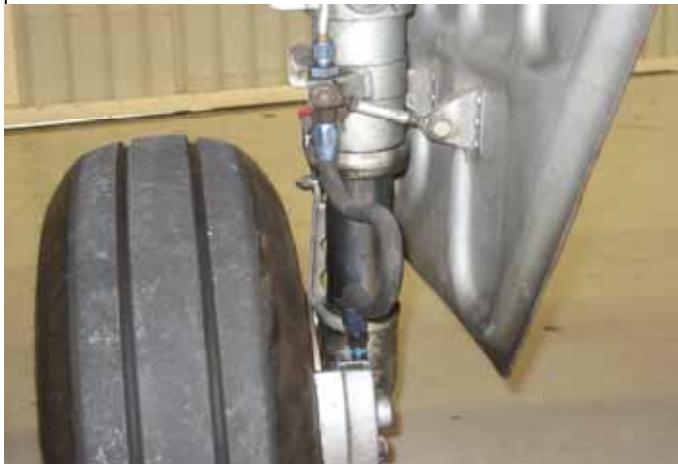
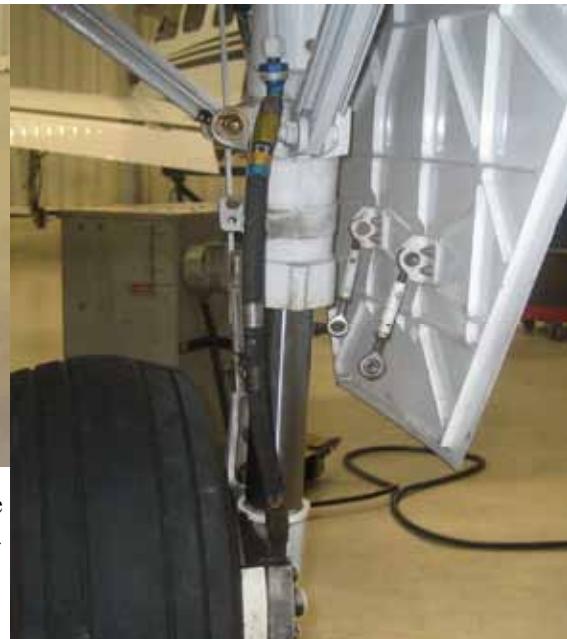
Brake hose and fitting movement with the airplane on the ground (above) and with gear extended in flight (right).

Discrepancy: Brake hoses require replacement and/or installation
